# Cost and Performance Report

## Pit 6 Landfill Operable Unit

Lawrence Livermore National Laboratory Site 300

UCRL-AR-128480

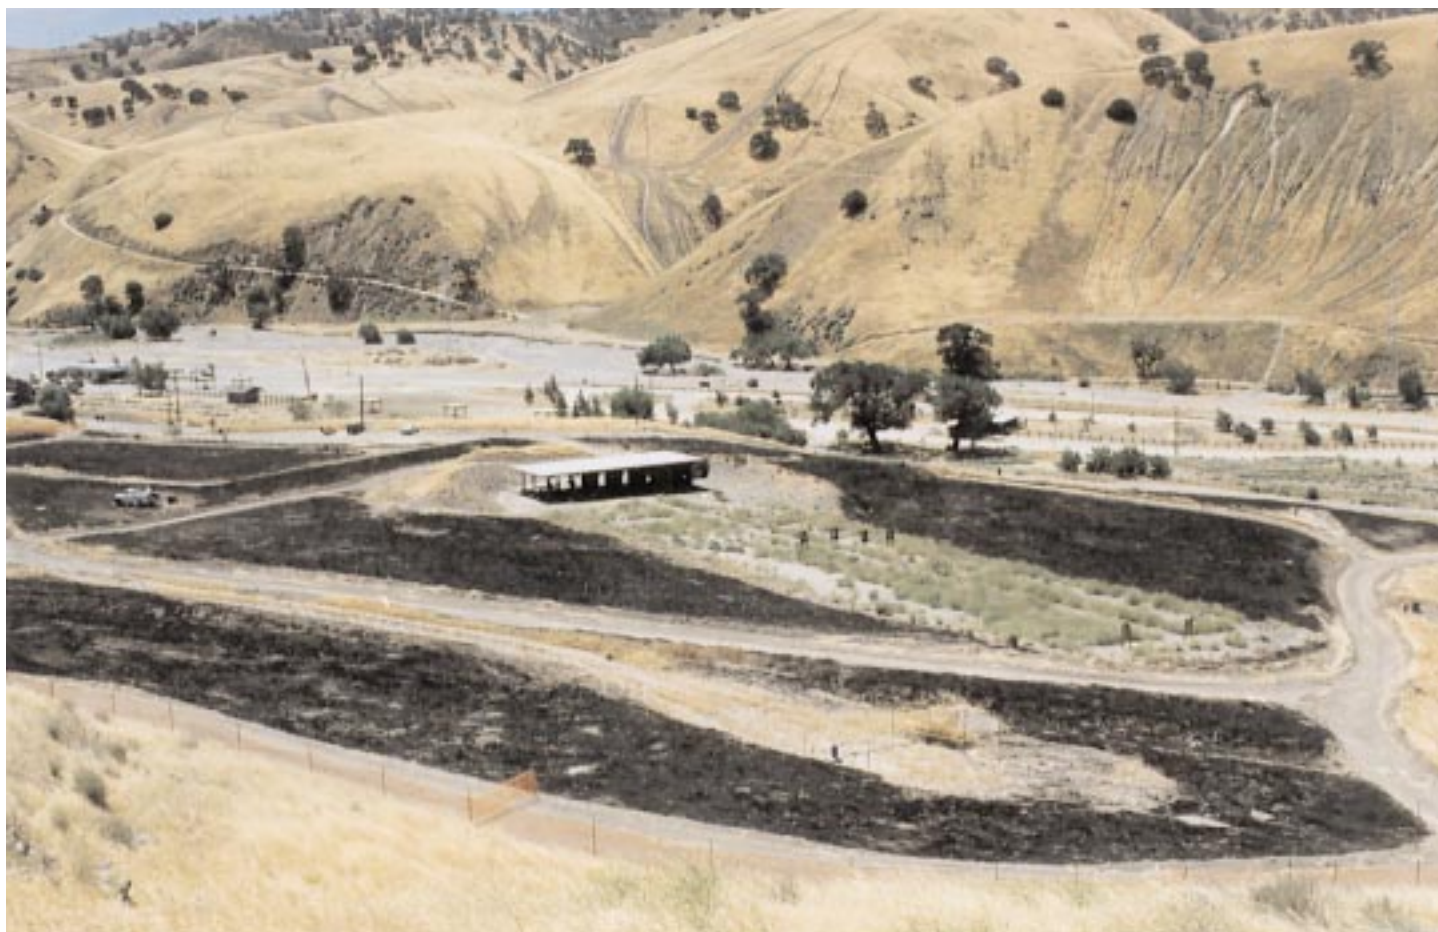
Pit 6 Landfill and overlying rifle range prior to cap construction; view looking south (May 1997).

After burial, all waste was covered with several feet of native soil. The landfill was not constructed with liners, containment structures, or leachate control systems. Due to safety considerations, no intrusive investigations of the buried material have been performed. A rifle range used for training exercises by LLNL was located directly over the landfill.

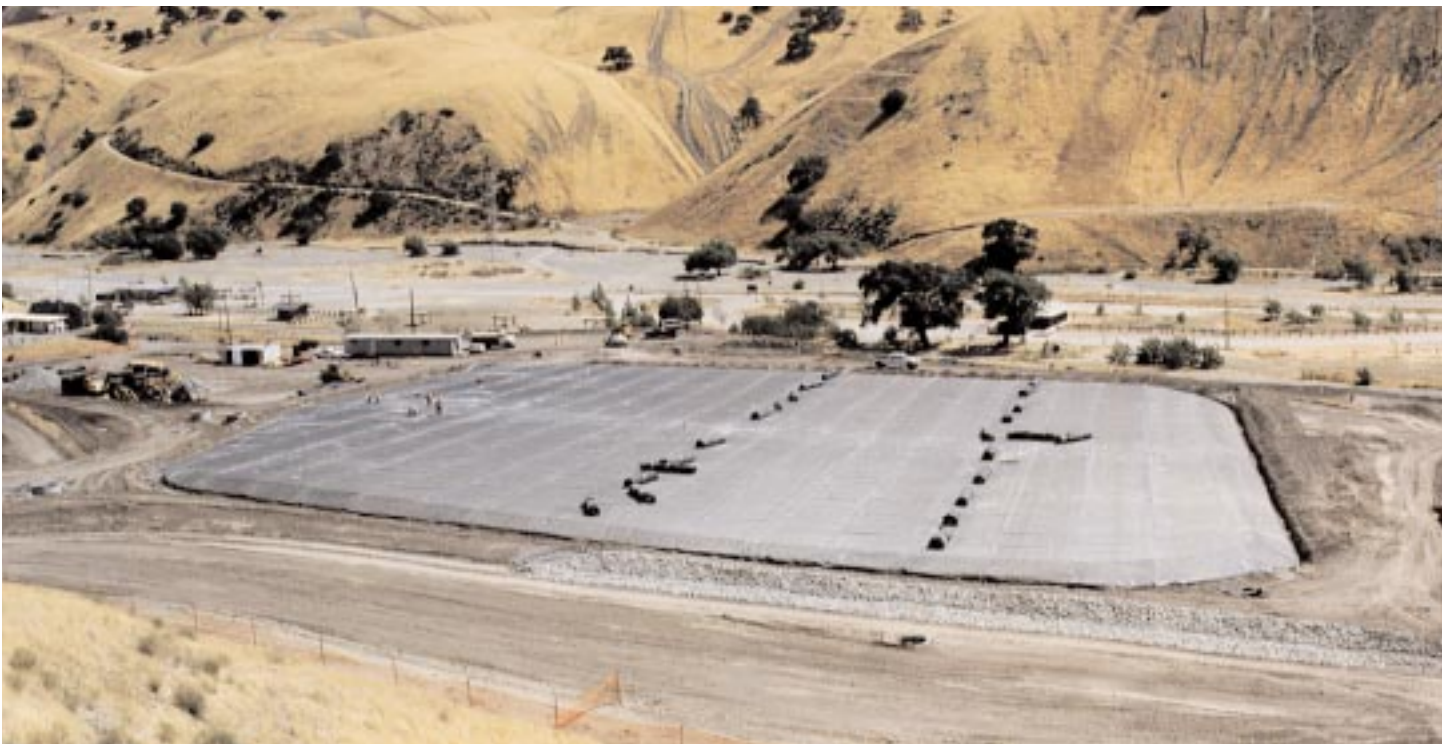
Pit 6 Landfill liner during installation; view looking south (July 1997).

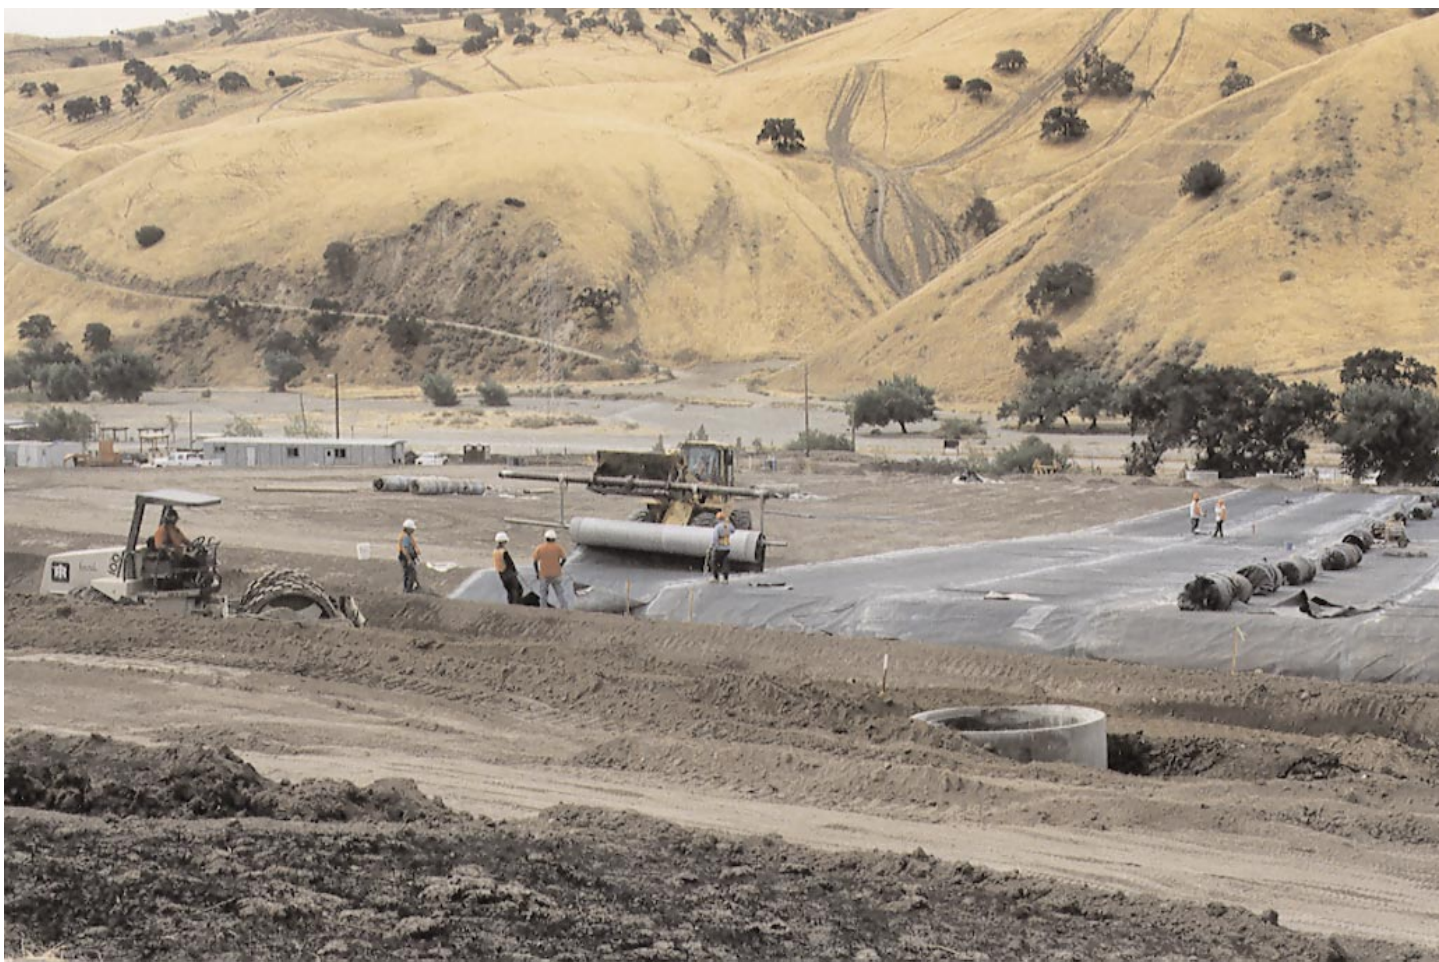
Installing the HDPE/geosynthetic clay liner (July 1997).

Selectively substituting geosynthetic materials for natural materials saved over \$500,000. Using a HDPE/geosynthetic clay liner in place of one to two feet of clay virtually eliminated concerns over possible desiccation cracks, low moisture content, and compaction of the impermeable liner during hot weather construction. Additionally, installation was much faster and quality assurance was more controllable.
